REPORT OF INVESTIGATION

Surface Nonmetal Mine
(Sand & Gravel)

Fatal Powered Haulage Accident
July 15, 2006

Terrassa Sand & Gravel #1
Terrassa Sand & Gravel, Inc.
Barrio Pinas, Puerto Rico
Mine I.D. No. 54-00081

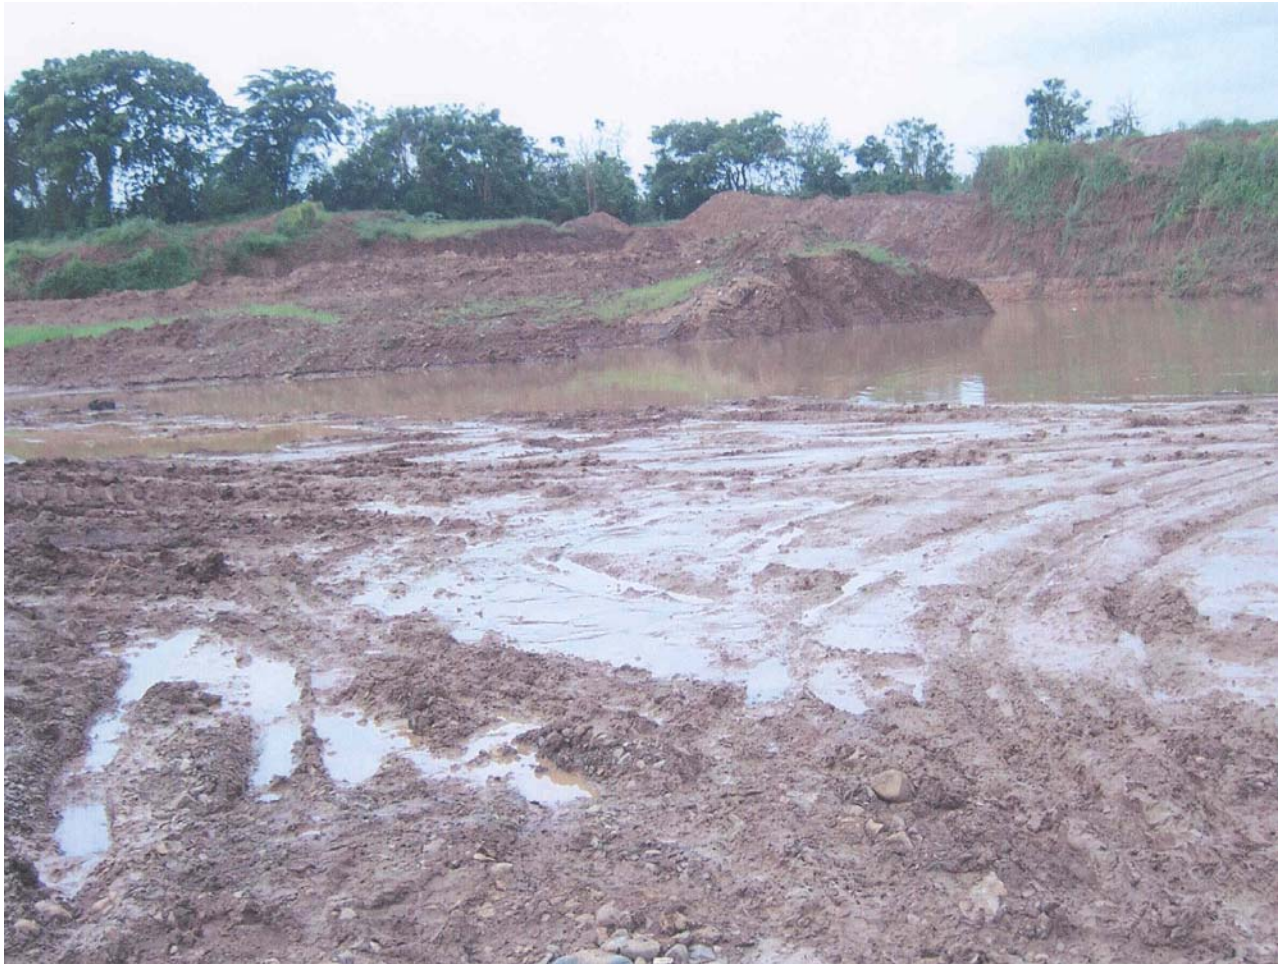
Miguel Vazquez, truck driver, age 61, was fatally injured on July 15, 2006, when the haul truck he was operating in the mine extraction area backed into a water filled pit.

The accident occurred at the mine extraction area located near the La Plata River. The area around the accident site was fairly level but muddy. The pit and its adjacent area were submerged. The water was about five feet from the pit's edge at the location where the truck entered the pit. The pit had a near vertical drop off and was approximately 20 feet deep. The edge of the pit could not be seen through the muddy water.
